Incident Hot Sheet

Date: 11/1/18

Description:	Broken Nylon Web Choker
<p>The CO-6 Purge Filter was setting in the cribbing in a horizontal position. The crew had to lift the CO-6 Purge filter from a horizontal position into a vertical position in order to set the equipment in the temporary steel structure. The crew barricaded the work area, completed the lift logs and three critical lift plans (main crane, tailing crane and Cabot Corporation lift plan). The crew rigged four 7/8 x 16' steel chokers to the top of the equipment and to the main crane. The crew installed a 3"X20' (10,000 lb.) nylon web choker to the bottom cone section of the purge filter and to the tailing crane. Softeners were placed on all identified sharp edges. Both cranes were being signaled by the superintendent. All other employees were stationed out of the lift zone and behind the red barricade tape. The main crane had the CO-6 Purge filter almost vertical when the choker on the tailing crane rubbed against one of the four access door stud bolts/wing nuts. The result of the choker rubbing against the lower access door stud bolt, cut the nylon web choker, causing the unit to shift approximately 6 inches. The b

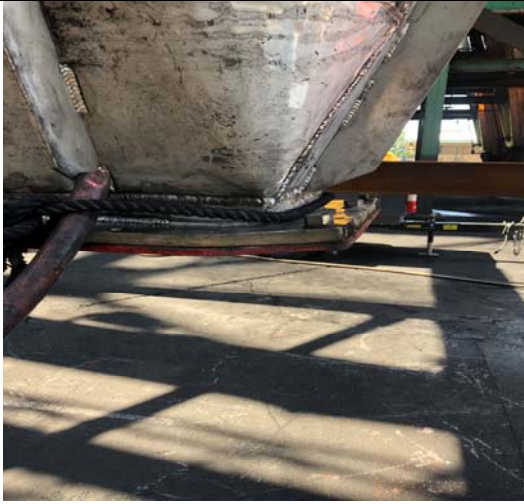
Picture Description Damage to the corner of the steel plate flange	Picture Description: 3"x20' nylon web sling damaged during critical lift

1.	The Purge CO-6 Purge Filter was offloaded by others and set upside down (180 degrees) on the cribbing and four legs. The legs were bolted to the four lifting lugs. <i>This was not in accordance with the manufactures recommended lifting plan.</i>

1.	Focus audits to verify employee training (Pre-task, Rigging and signal person)
2.	Send recommendations to the "Planning of Lift Task Force" to include, critical lift plan review by management, manufacture recommendations, identify pinch points and sharp edges, spotter(s)
3.	<u>All critical lifts will be planned and documented days in advanced and reviewed by subject matter expert prior to performing the lift.</u>
4.	
5.

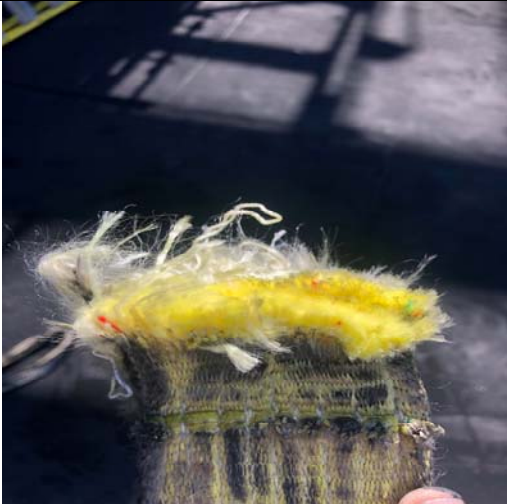
2.	One 3"x20' nylon web choker was used on the tailing crane instead of a steel choker. <i>Steel choker would have provided resistance to sharp edges</i>

4.	The 2'x2' access door stud bolts and wing nuts sharp edges were not identified. <i>Superintendent protected nylon web choker with softeners from all known sharp edges. Superintendent was unable to see the access door due to his position.</i>

5.	No one from the crew was assigned to watch the tail crane. <i>A dedicated person should have been assigned to watch the tailing crane lifting activities.</i>

6.	Root Cause: Policies and Procedures No policy/procedure – When the structure was not set in the proper lifting configuration (per manufacturer recommendations) and was identified as critical, there was no required procedure for additional review and approval by Management.
