Employee Struck by Broken Link from Lever Chain Hoist

IHS # 54 : Employee Struck by Broken Link from Lever Chain Hoist

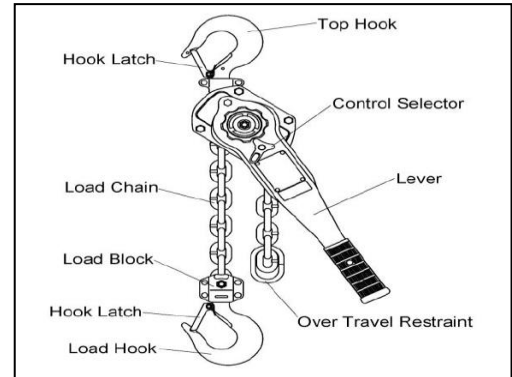
Diagram of Lever Chain Hoist

A Cajun jobsite recently experienced an incident that resulted in an employee being injured by a broken link of a lever chain hoist that was being used improperly. A crew was tasked with adjusting the two caisson clamps of a vibratory hammer from 48-inches to 24-inches. The load chain of the lever chain hoist had been wrapped around the caisson clamps and the load hook and top hook of the chain lever hoist had been connected together.

In theory, cranking the hoist would pull the caisson clamps together. However, the wedges of the caisson clamps had not been properly loosened which resulted in the load chain of the lever chain hoist binding down on 4 sharp edges of the caisson clamps. One of the edges of the caisson clamp bit into a link of the chain causing damage to the link, reducing the capacity of the chain. The damaged link ultimately snapped, which caused the load chain to break free and injure an employee.

The investigation revealed that the crew had improperly rigged the lever chain hoist to the caisson clamps by attaching hook to hook and using the load chain as a sling. This action as well as the route utilized around the caisson clamps put the load chain in a bind around four 90-degree corners. Also, employees were unnecessarily positioned within the line of fire of the load chain allowing for multiple people to be struck in the event that the load chain failed.

Prevention → Follow manufacture guidelines for inspecting a lever chain hoist

Prevention → Tag out and remove tools that do not pass inspection

Prevention → Follow manufacture guidelines for proper use and hook configuration

Prevention → Prior to use, know the maximum weight of the object being hoisted or pulled

Prevention → Employees are to be trained on how to use a lever chain hoist
