Category: Superintendent News Alert

Document #: SNA-CDF 8

Document Title: Hammer Line Failed While Lowering Hammer to Refuel

Owner: Cajun Industries, LLC

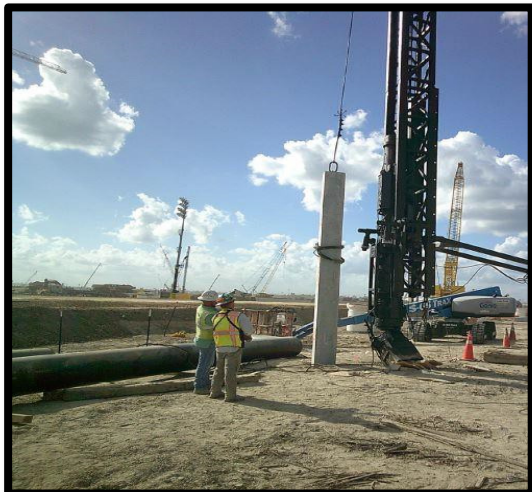
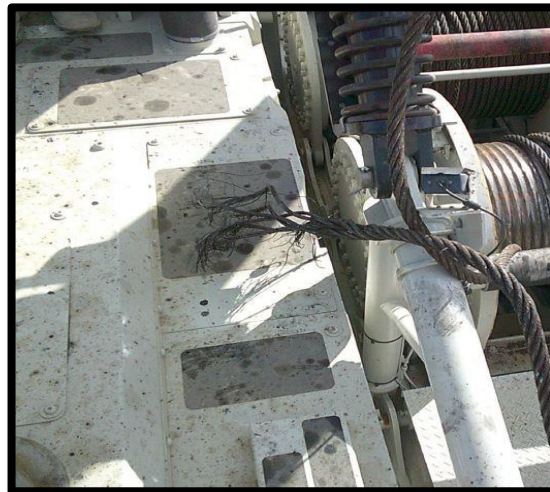
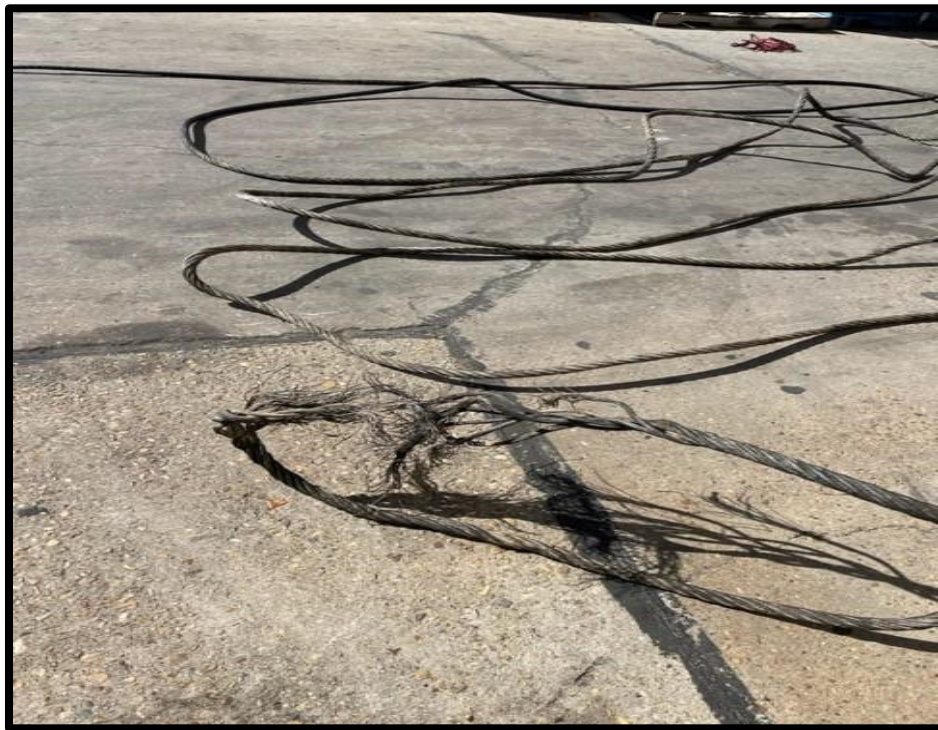
“During the process of lowering the pile driving hammer to the ground to refuel, the hammer line of the crane failed and snapped allowing the hammer to fall to the ground approximately 5 feet.”

1. All employees were in approved “employee safe zones” at time of incident.
2. No damage was recognized to crane cable in previous lead inspection.
3. Testing of damaged cable and lead sheaves did not indicate any manufacturer’s defects in the equipment.
4. Post incident, hammer cable showed signs of kinking and memory indicating that the cable was being shock loaded during driving.

1. Review the importance of “employee safe zones” with employees.
2. Equipment Inspection – Review cable inspection criteria with crews and operators to be able to recognize damaged cable during lead inspections and daily crane inspections. Employees should focus on identifying “kinks” and “dog legs” in crane cable during inspection.
3. Superintendents to evaluate pile driving equipment configuration in reference to the project driving conditions.
 - a. Consider the following adjustments to equipment configuration in hard driving conditions to prevent potential shock loading of hammer line cable:
 - i. Placement of trip assembly on hammer trolley (not too high, not too low)
 - ii. Use of hydraulic trip
 - iii. Two-parting hammer line
